## LOCAL POZZOLANIC MATERIALS IN AZOREAN BUILT HERITAGE

**Keywords:** Azores, heritage, pozzolans, renders

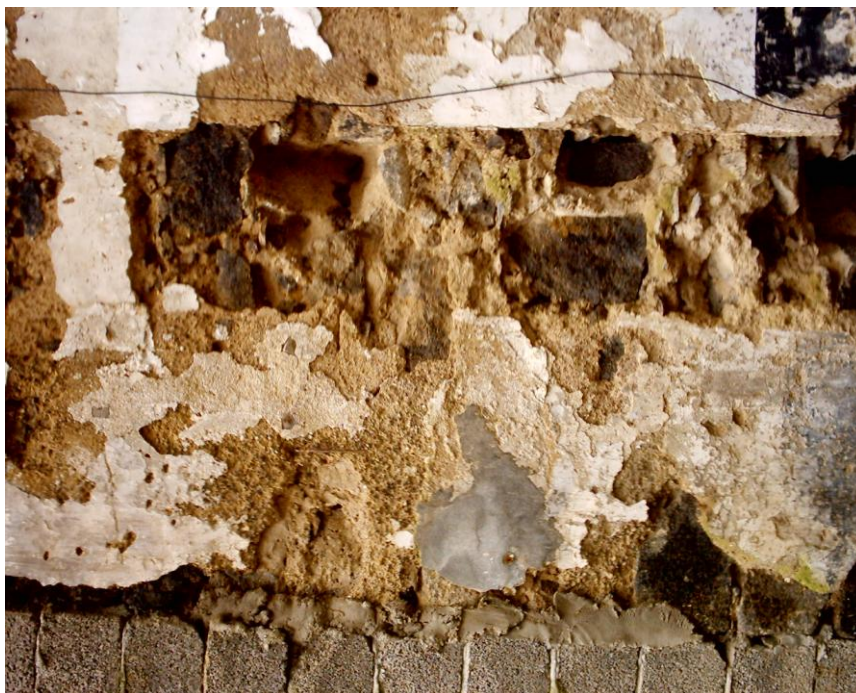
Mortars were extracted from two locations in the Azores island of S. Miguel: Ponta Delgada and Furnas. Upon an initial visual overview, it is clear that these renders show a brown/beige colour, sometimes quite strong, due to the use of local materials (Figure2). In this last case, the soluble fraction was high, around 50% and the mortars may have some earth content. In terms of mortars from Ponta Delgada, results showed a great variability and soluble fractions varied from 25% to 59%, although the range of 20% to 35% is characteristic of most of the analysed samples. Azores island mortars revealed an insoluble fraction composed of natural pozzolan, basaltic aggregate or volcanic tuff and in a few cases, black volcanic sand composed by ground volcanic rocks.

Figure 2 – Extraction of mortars in S. Miguel, Azores
